Manhole Inspection Summary

Manhole # S31CC_040MH

Location Address: **EUTAW ST**

Cross Street: **PRESTON ST**

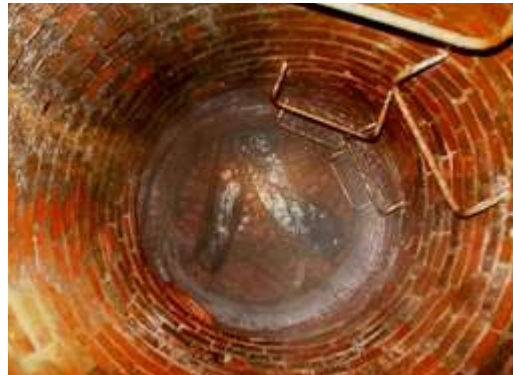
Top View

☒ **Debris** (not Condition related)

Bench debris.

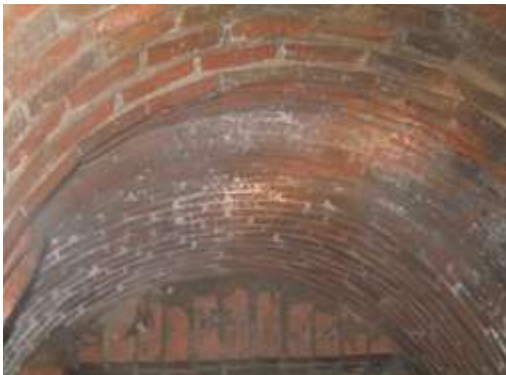
Defect

Corbel and Barrel infiltration.

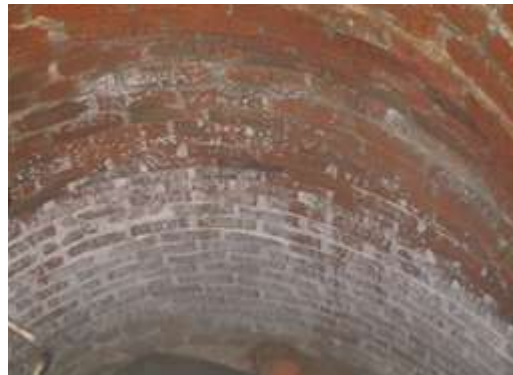
Defect

Corbel infiltration.

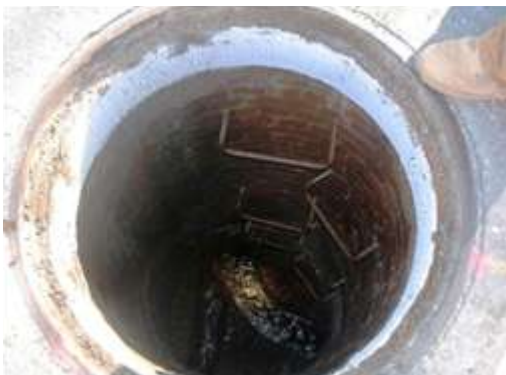
Defect

Frame leaks. Adjustment, Corbel and Barrel infiltration.

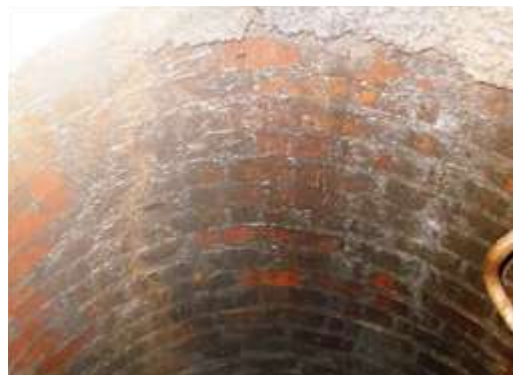
Defect

Adjustment infiltration.

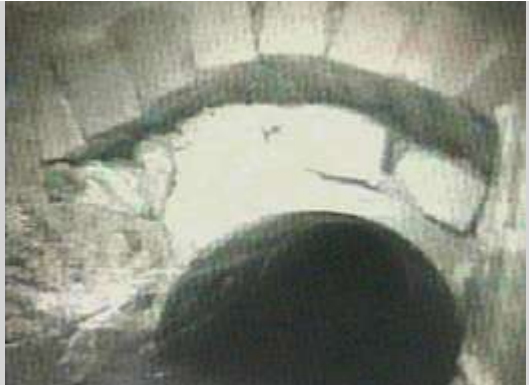
12 in. Circular Gravity Sewer Pipe Out @ 12 O'Clock

Barrel deterioration, loose brick and infiltration.

Infiltration: **Evidence** Pipe Seal Cond: **Cracked**
